Soils & Water Testing

Laytonville Rancheria - 2017

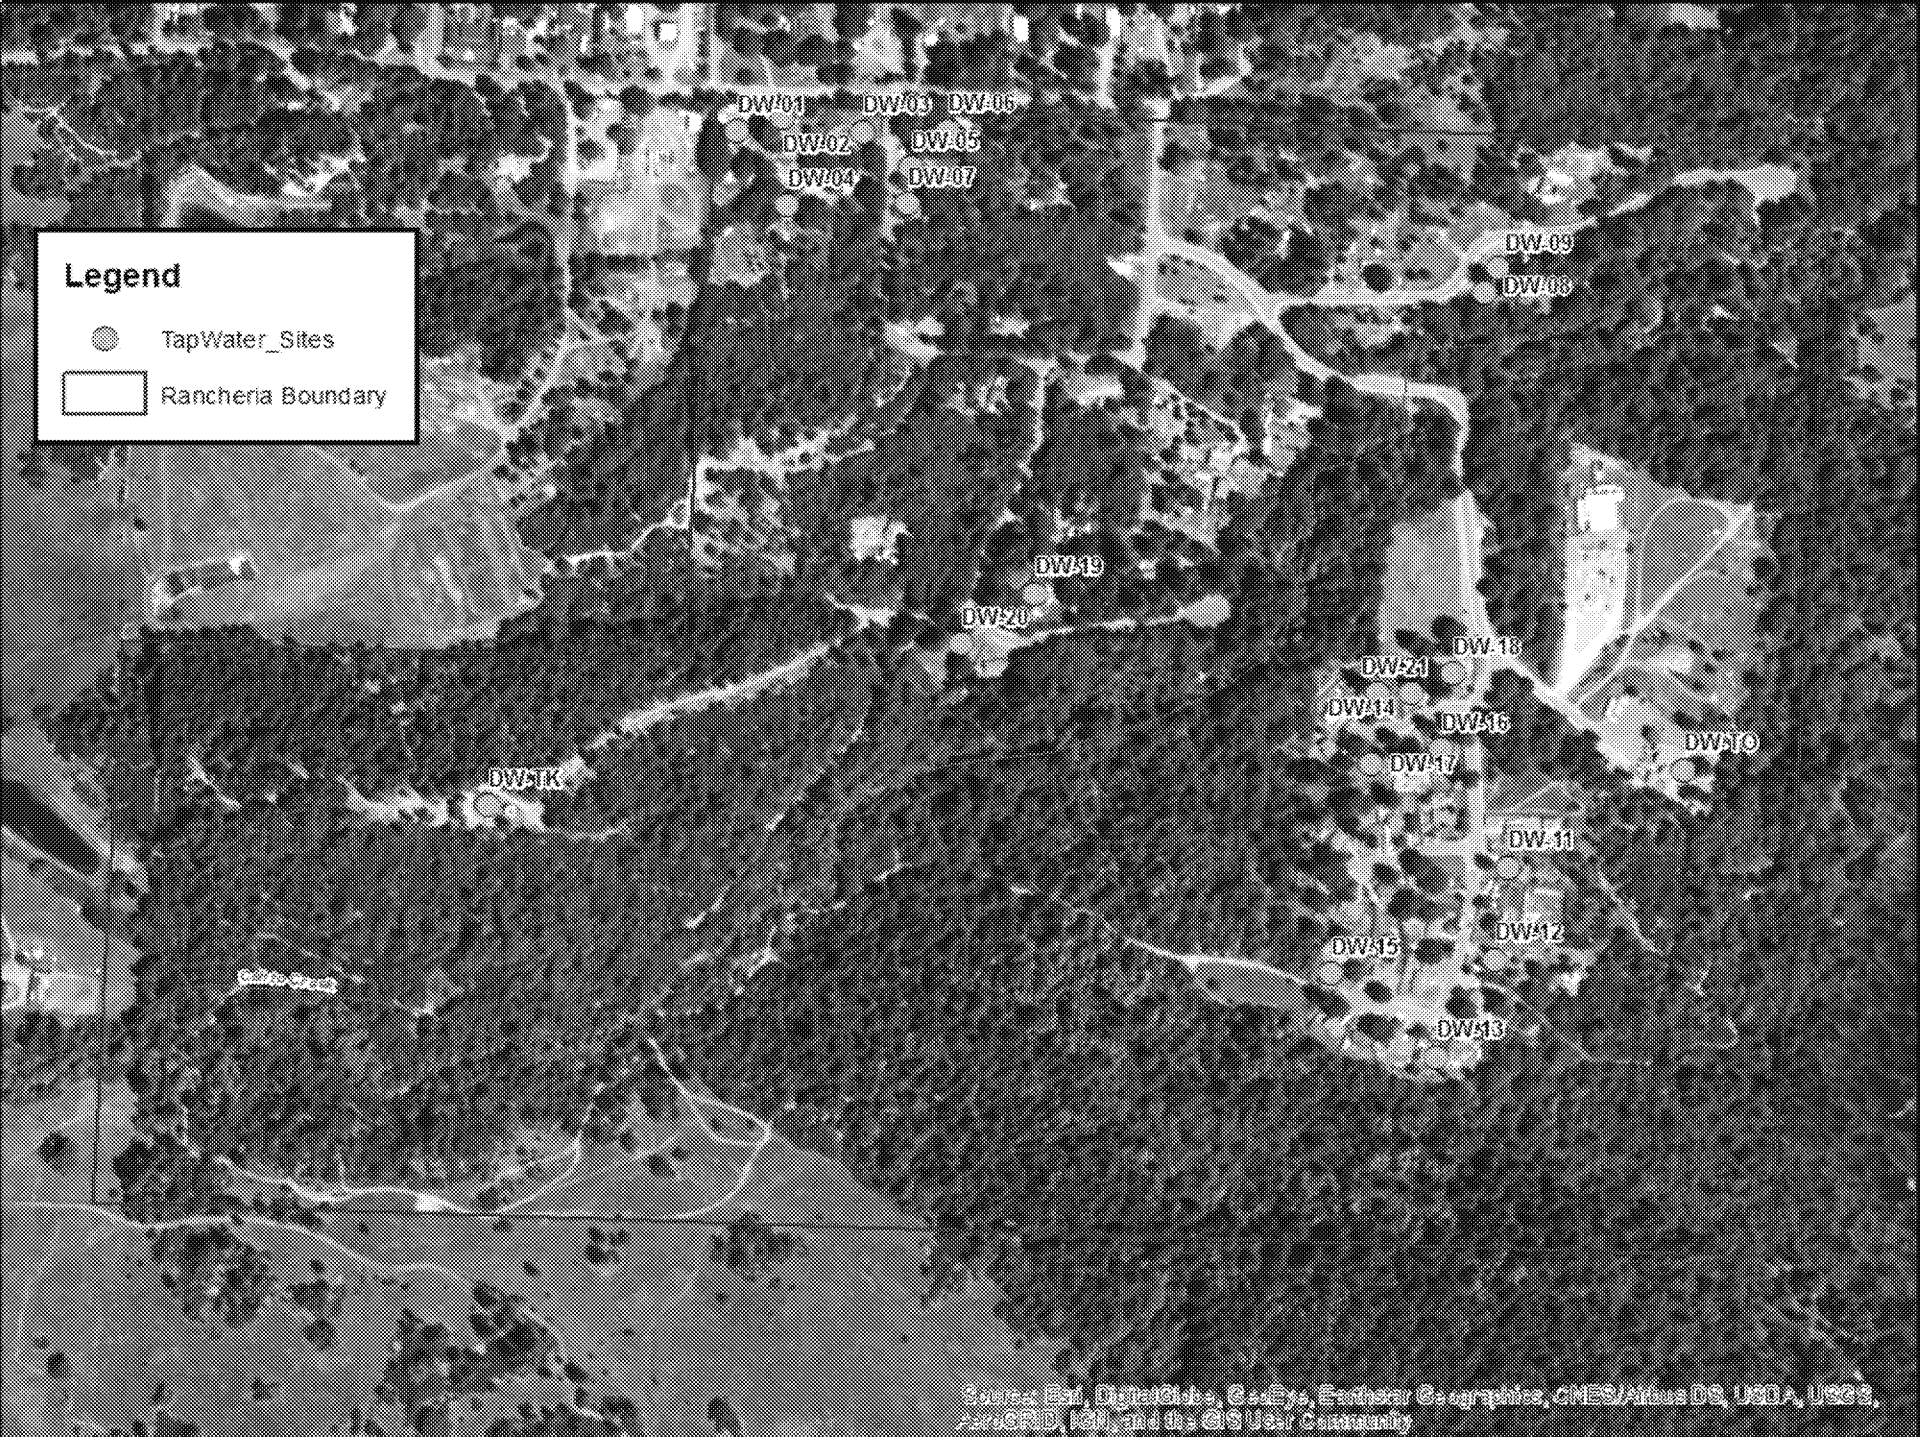
- Rancheria has been connected to district water system since 1970's.
- Twenty-two homes were selected by the tribe.
- Samples were also taken at the supply tank and tribal office.
- Samples were tested for 42 constituents or “analytes”.
- Federal and State Maximum Contaminant Levels (MCLs) standards apply.

TapWater_Sites

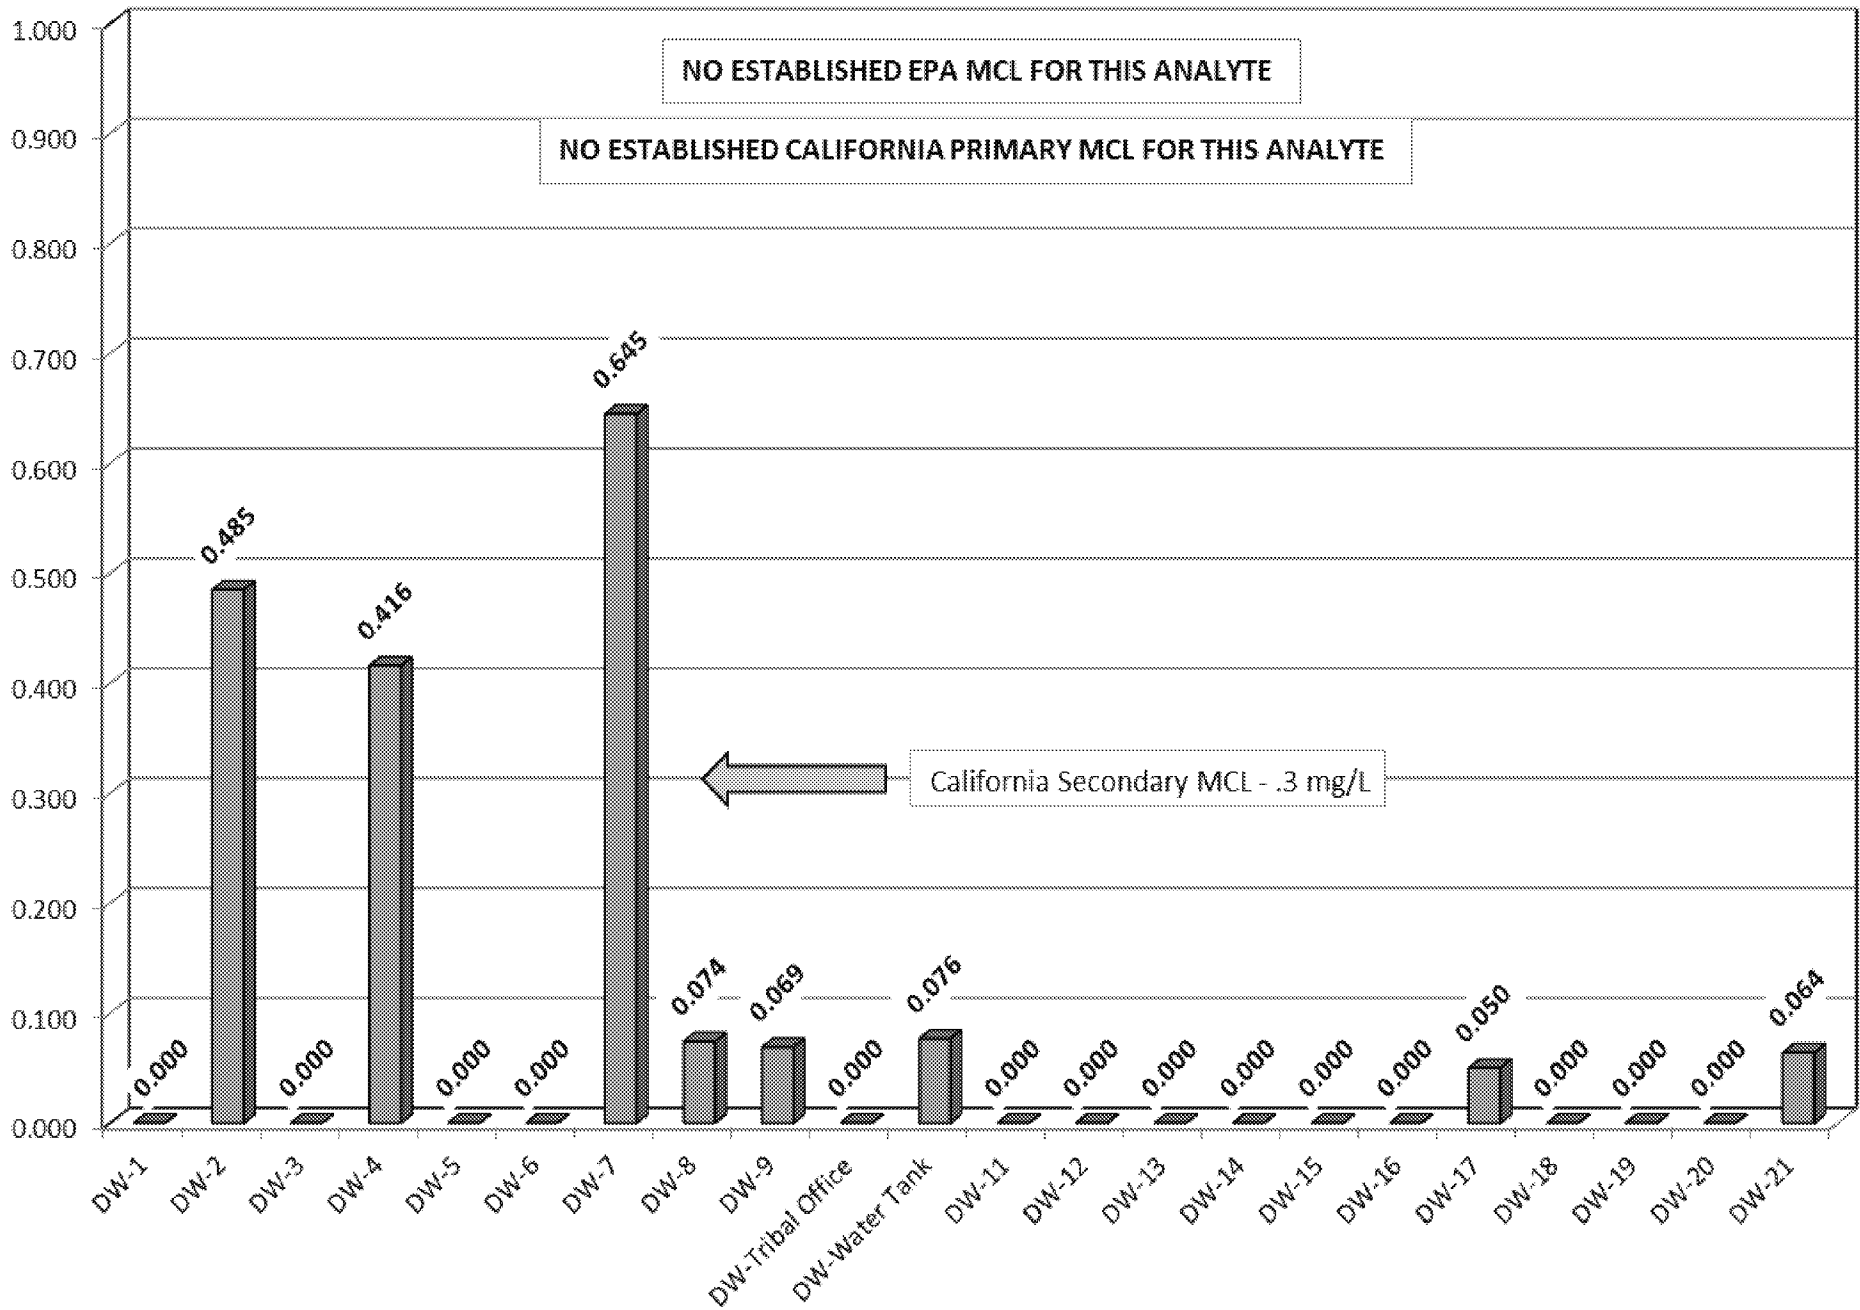
Tap Water Samples - Iron - mg/L

- Only 2 analyte MCLs were exceeded:
 - 3 sites exceeded the CA Secondary MCL for Iron.
 - 1 site for exceeded the EPA Regional MCL and CA Secondary MCL for Arsenic.

- Dielectric Effect – Galvanic Corrosion
 - Mismatched plumbing components – Copper and Galvanized Steel or Iron.
 - Causes leaching of elements, such as Iron, to accumulate inside of pipe and into the water itself and could lead to pipe failure.

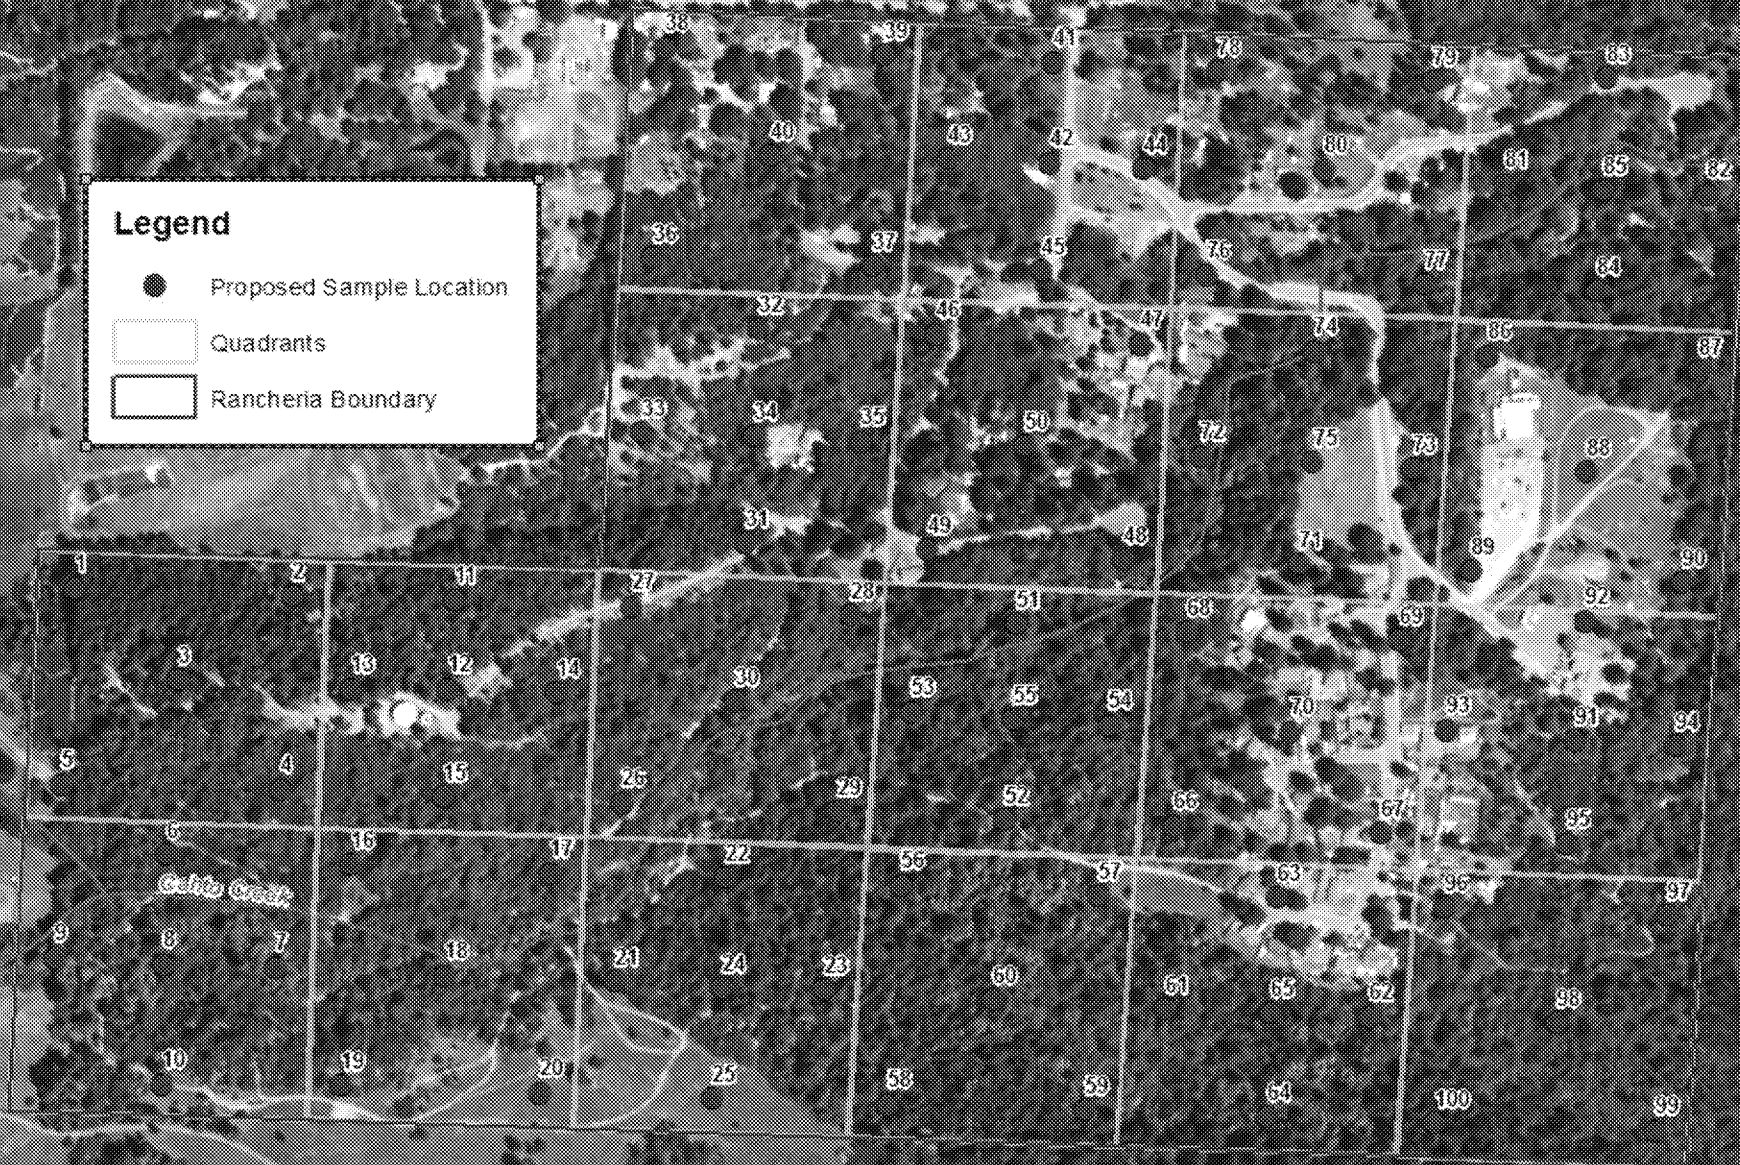
- Tribal land divided into 20 testing areas or Quadrants:
 - Broad in scope (shotgun approach)
 - Five samples per quadrant – 100 samples total
 - 100 samples combined into 20 composite samples

● Proposed Sample Location

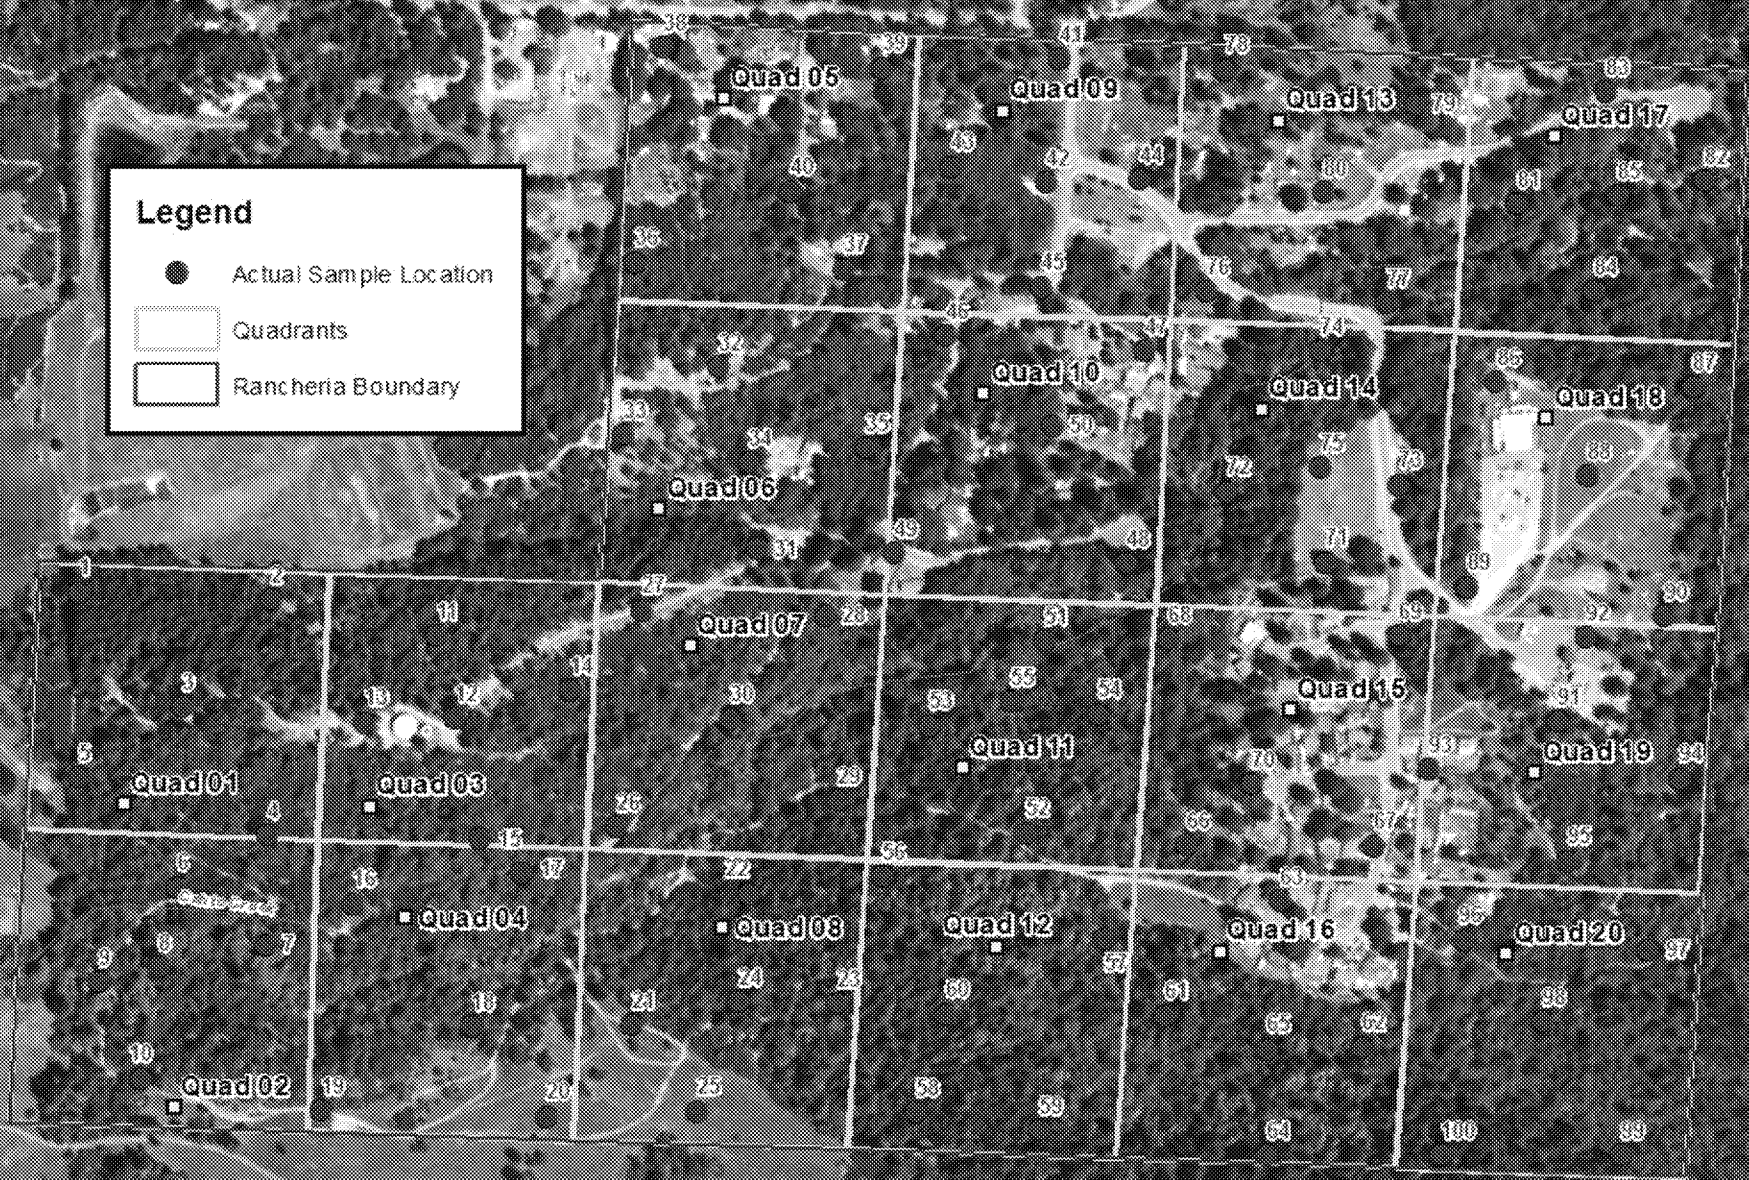
● Actual Sample Location

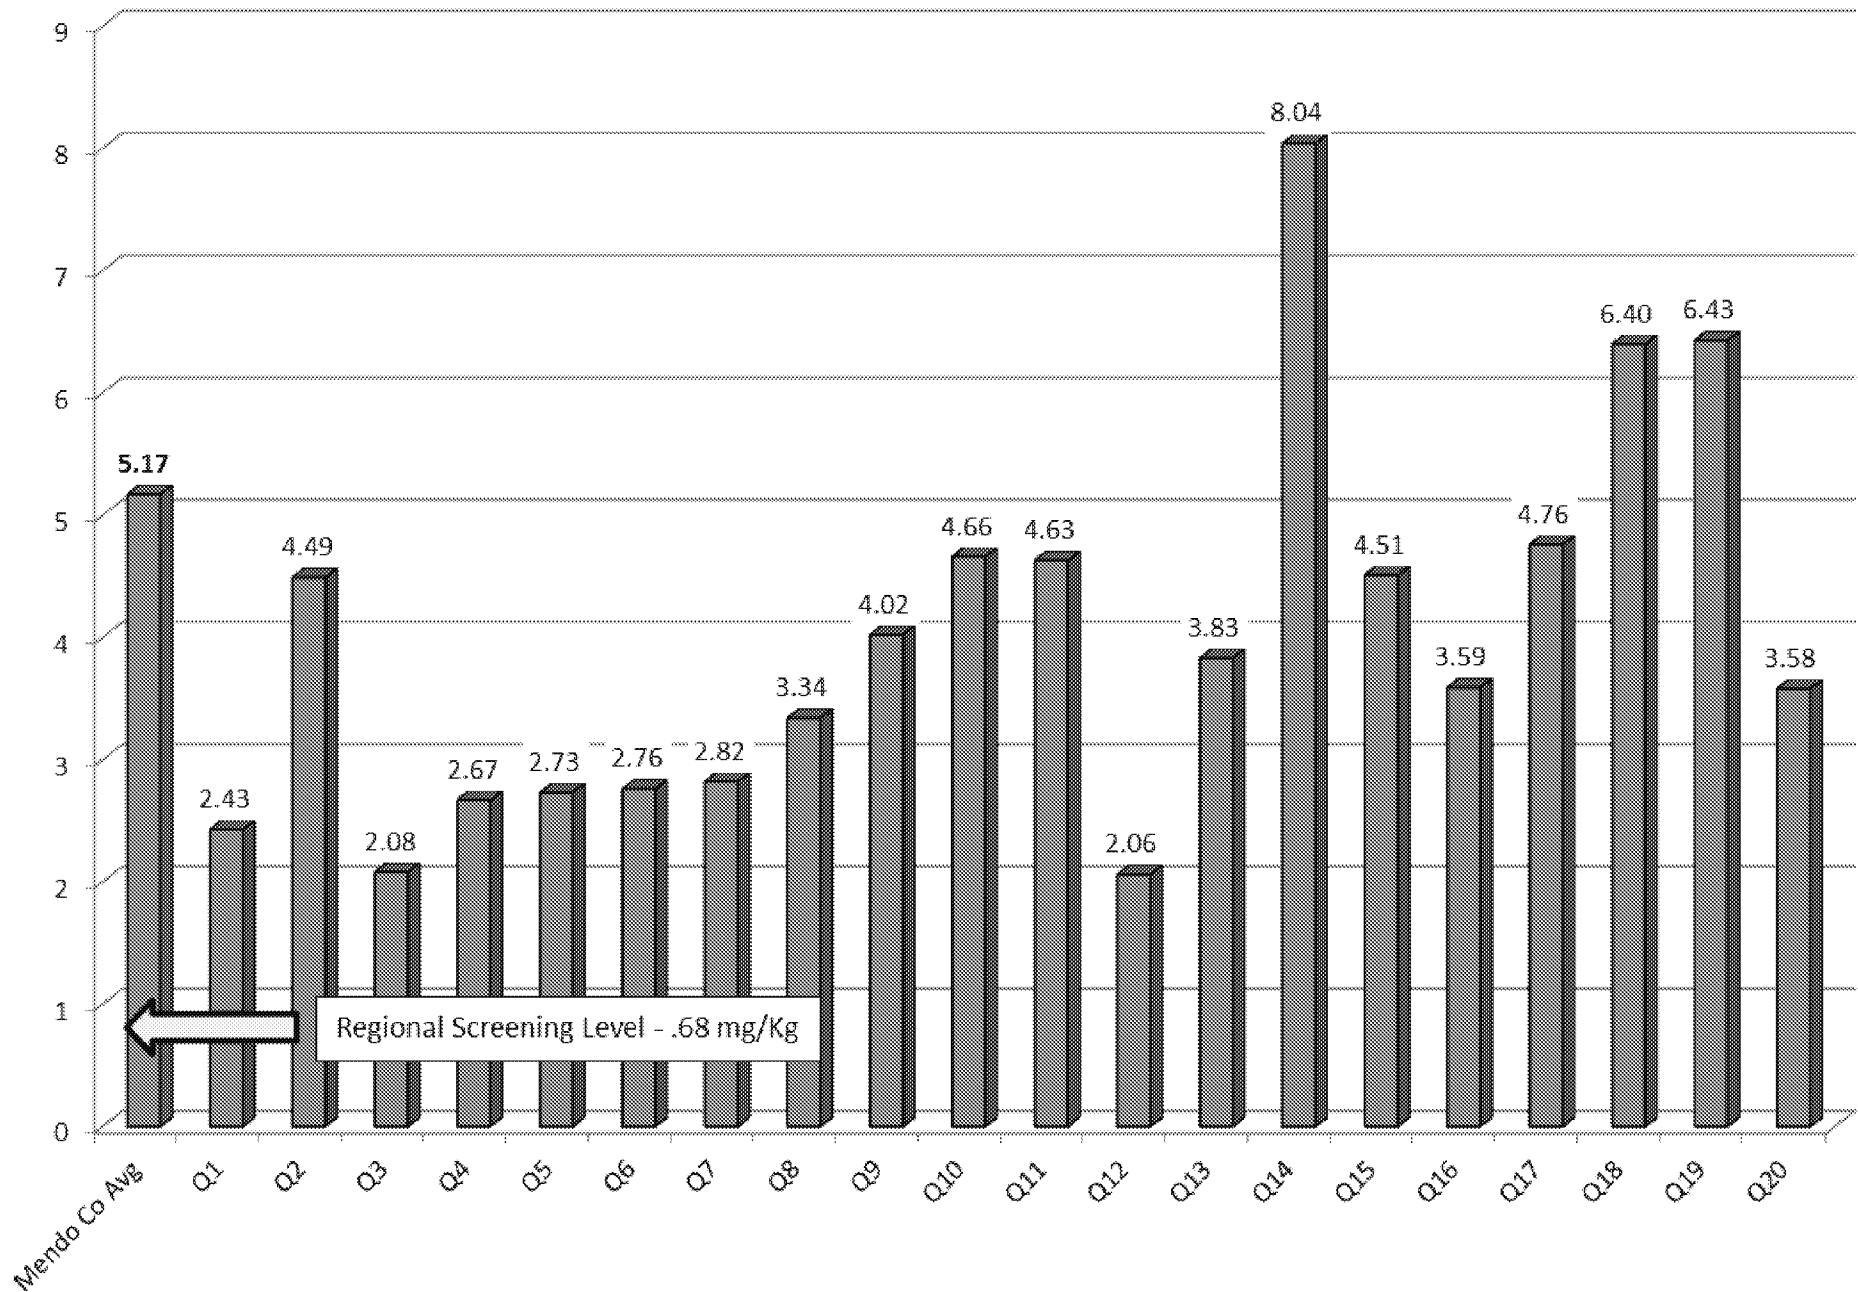
- Based on test results, two concerns came forth: Arsenic levels and Dioxin Toxicity.
- Hexavalent Chromium (aka Chromium 6) was not detected.
- Arsenic was detected above the RSL of .68 mg/kg.
- Arsenic is a naturally occurring background element.

- Arsenic – ATSDR Recommendations:
 - Handling treated wood appropriately – gloves, saw dust.
 - Washing hands after handling treated wood or structures made of treated wood if using bare hands.
 - Limit contact with soil by use of dense ground cover, such as a lawn or other vegetation. Other options could include gravel or wood chips.
 - Dust and soil control in and around the home.

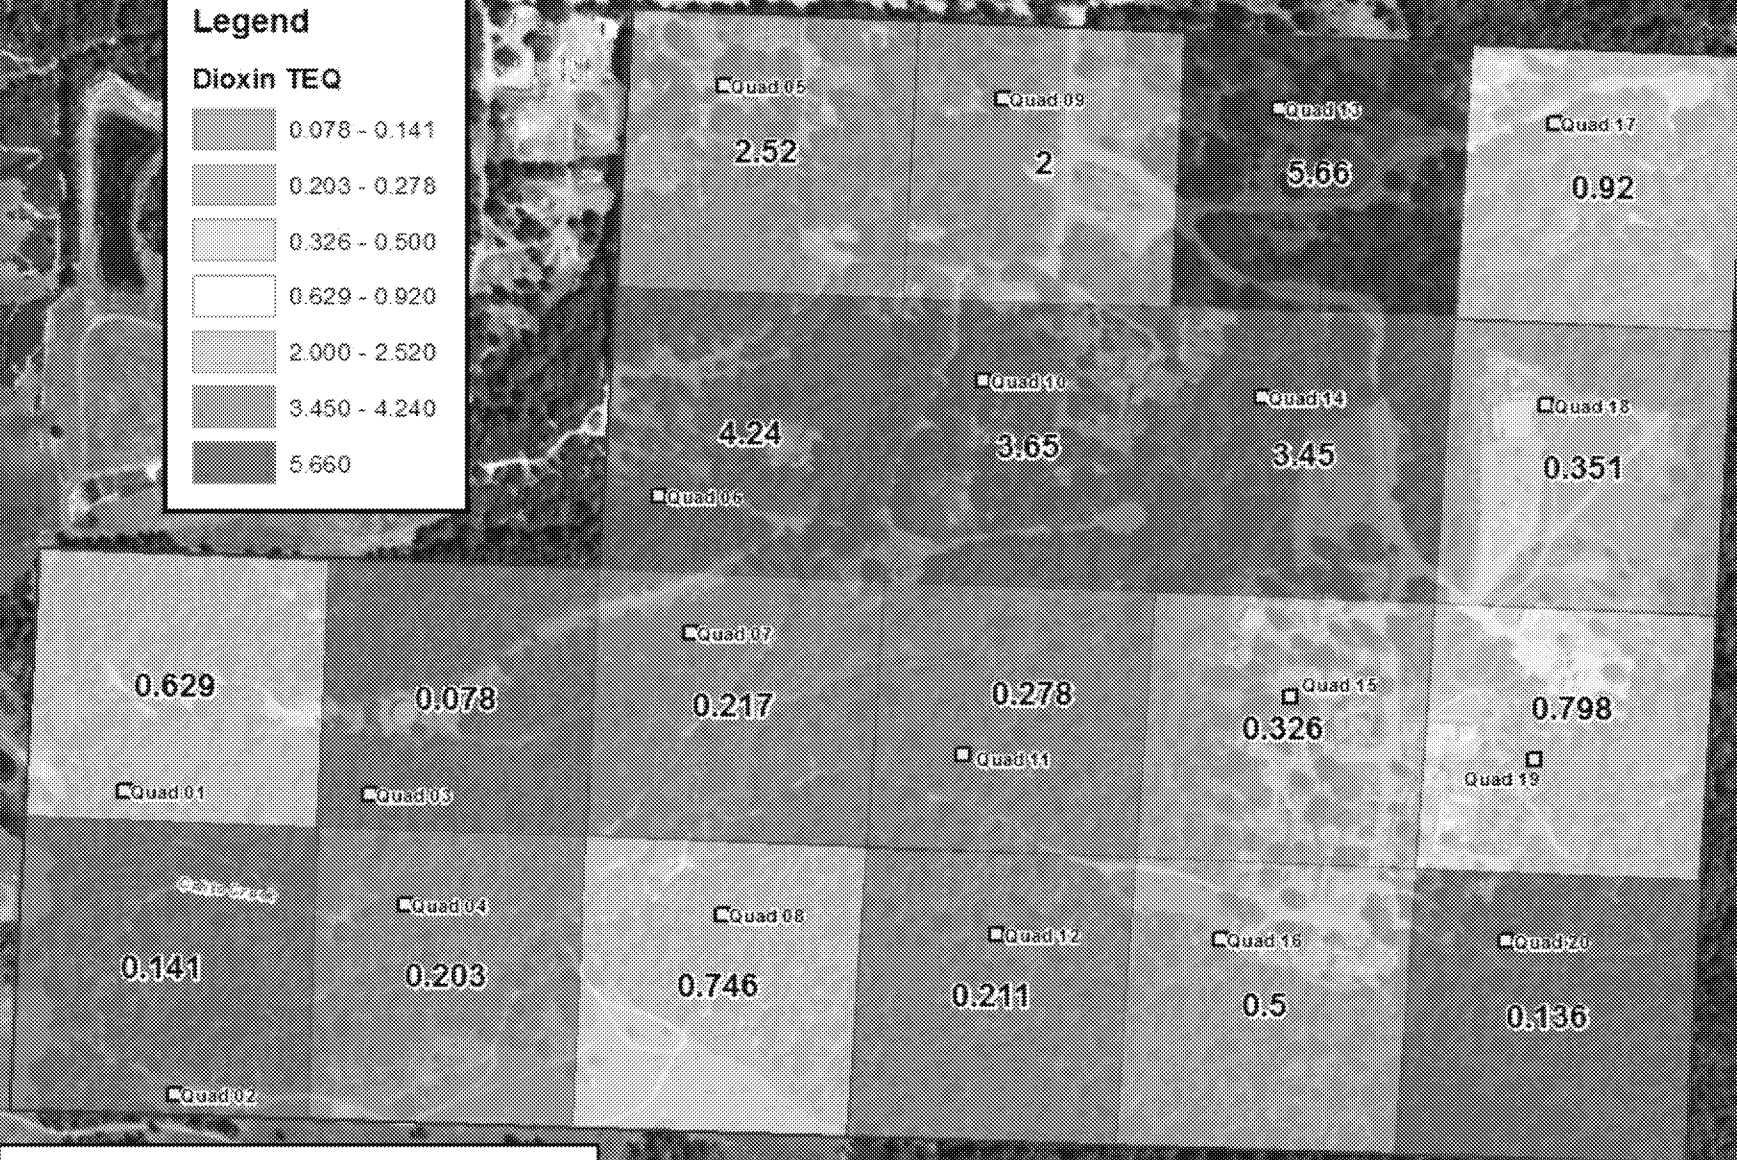
Toxicity Equivalency Quotient (TEQ) - Dioxins/Furans

- Soils tested for 17 compounds.
 - 7 Dioxin Compounds
 - 10 Furan Compounds
- Contamination level expressed a Toxicity Equivalency Quotient (TEQ)
- Regional Screening Level TEQ – 4.8

This map illustrates the Toxicity Equivalent Quotients (TEQ) by quadrant.

The TEQ RSL for Dioxins/Furans is 4.8.

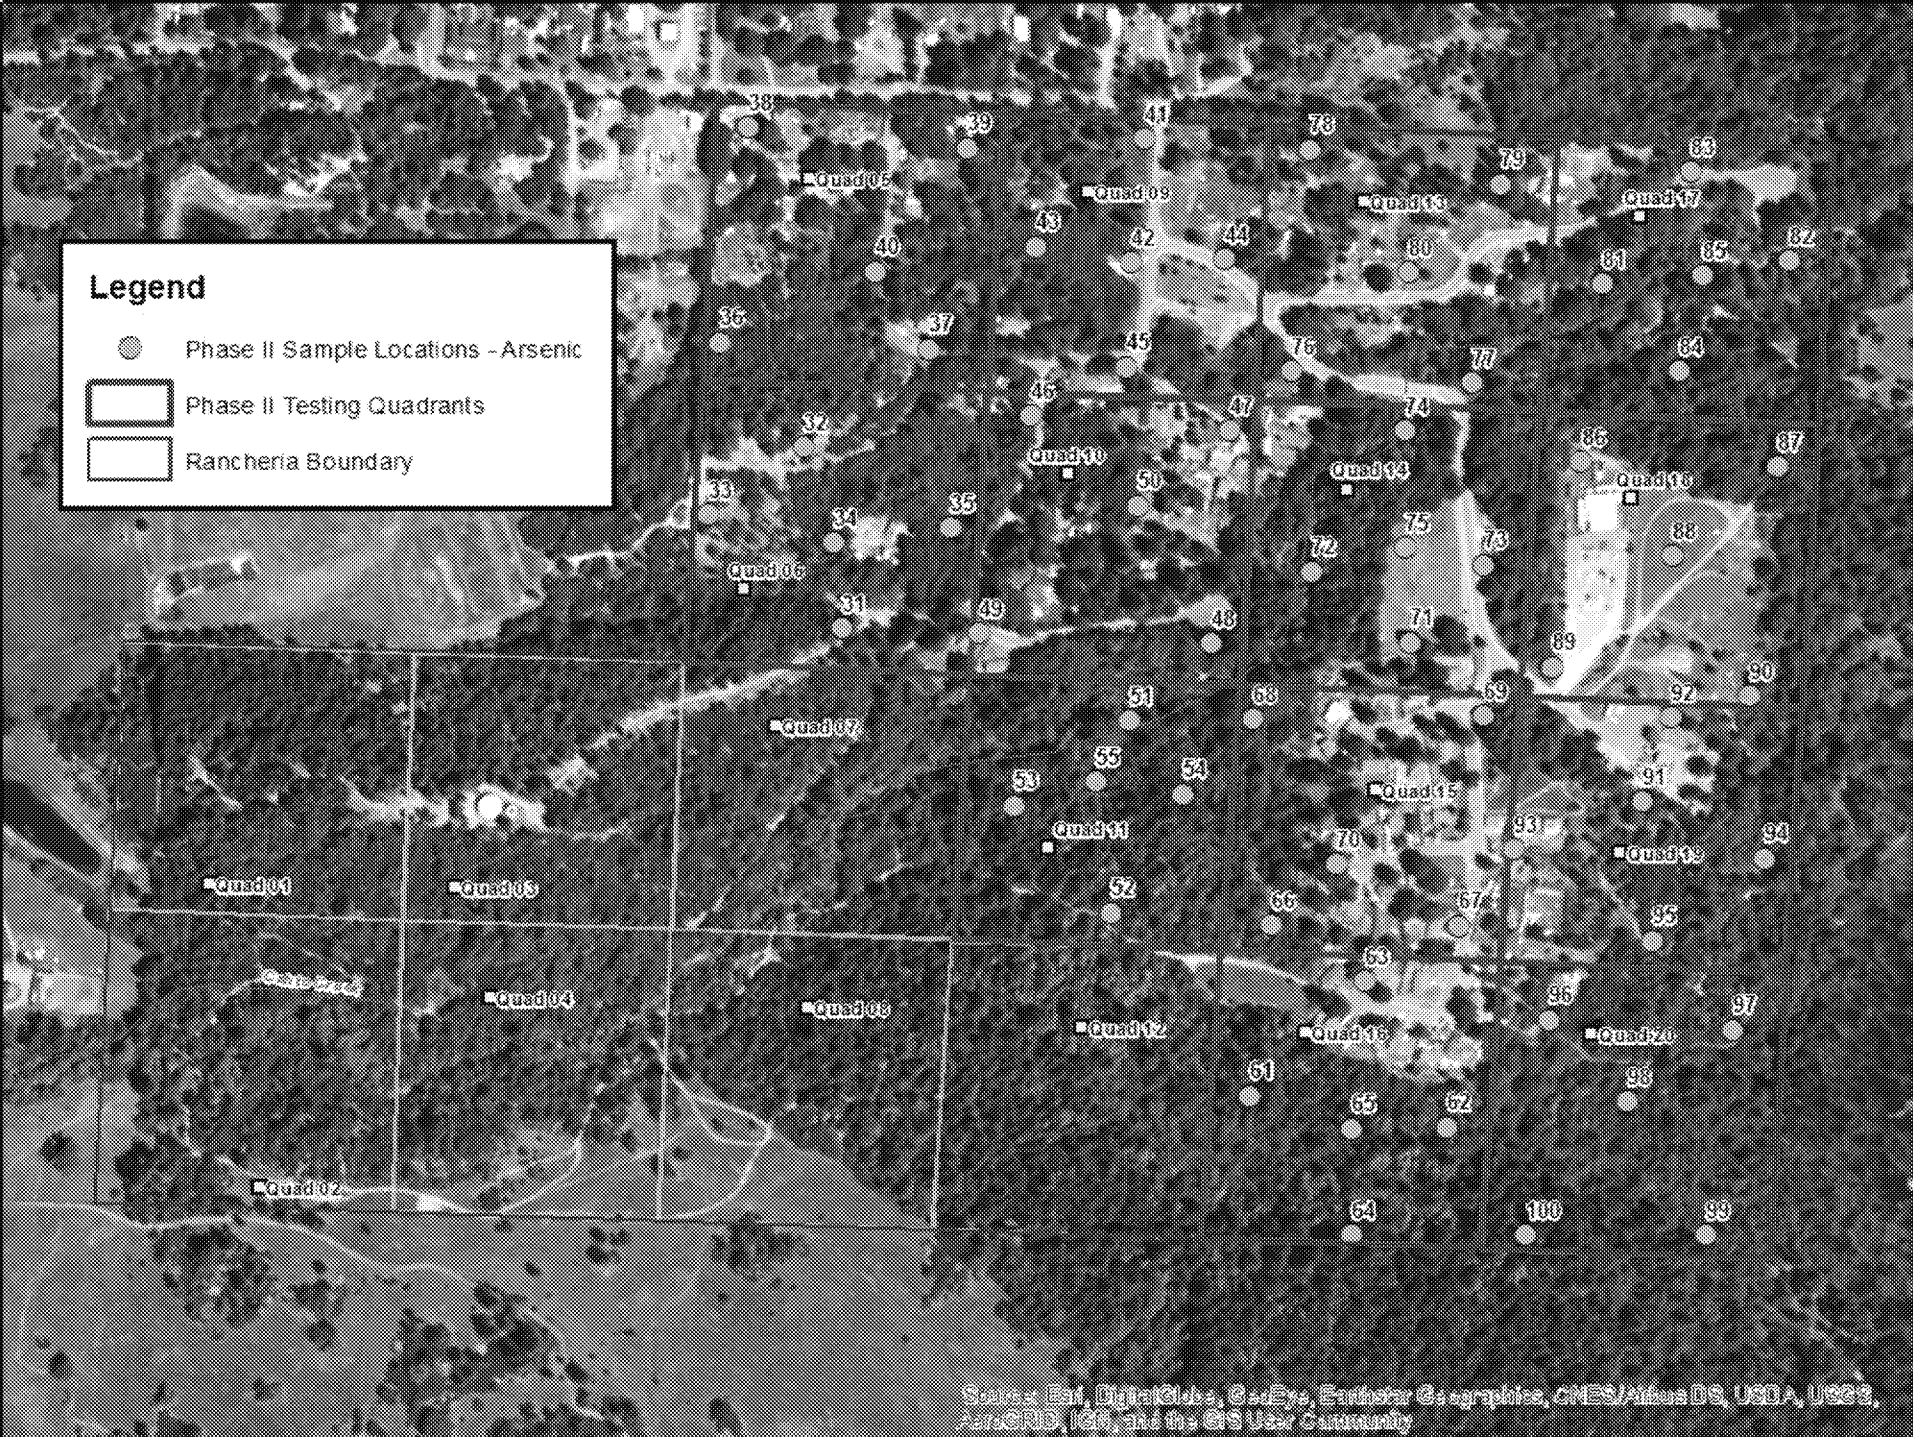
- Arsenic was only analyte that had levels above RSL of .68 mg/Kg.
- Based on 65 soil sampling sites, Arsenic level average on tribal land is 4.22 mg/Kg with a low of 1.58 and a high of 10.30.
- USGS soil data for Mendocino County – Arsenic content average is 5.17 mg/Kg.

● Phase II Sample Locations - Arsenic

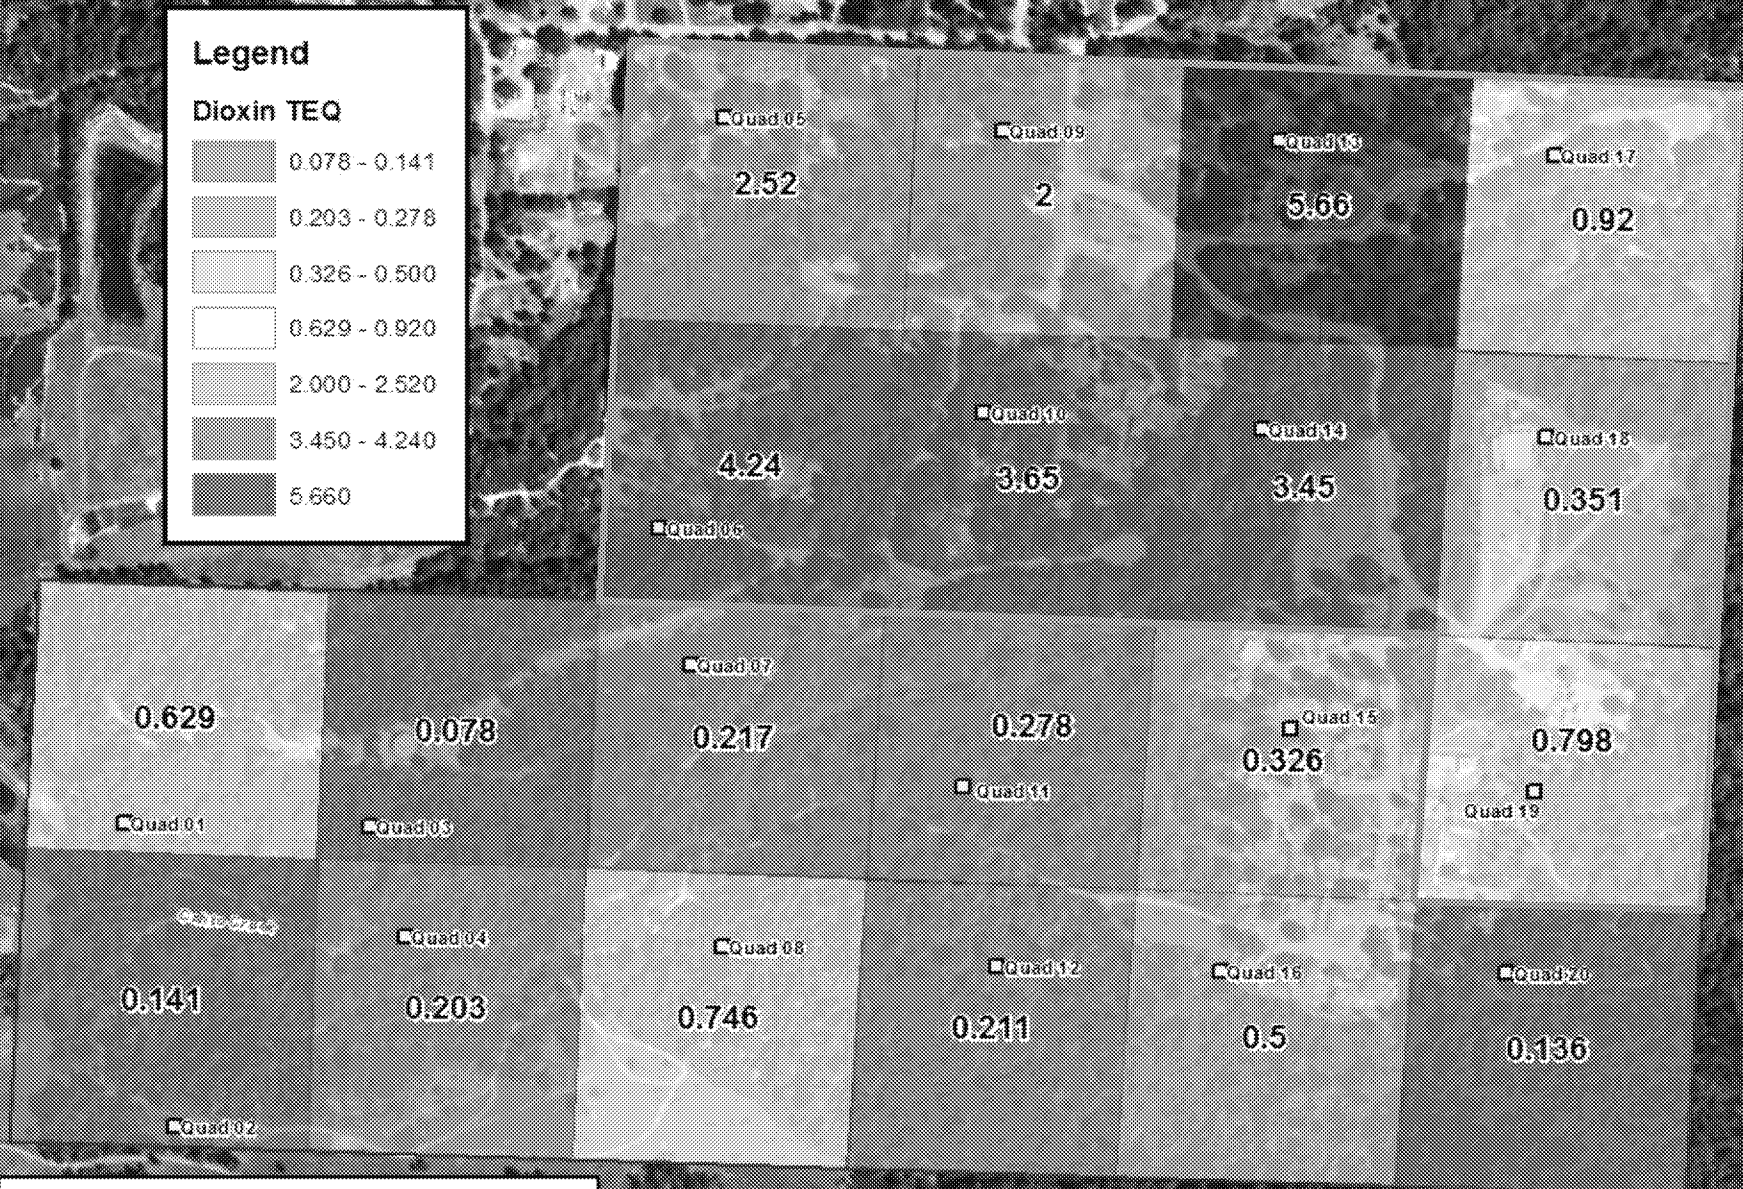
- 45 soil samples were taken and tested for Dioxin/Furan toxicity levels.
- 5 locations had a TEQ higher than RSL of 4.8.

This map illustrates the Toxicity Equivalent Quotients (TEQ) by quadrant.

The TEQ RSL for Dioxins/Furans is 4.8.

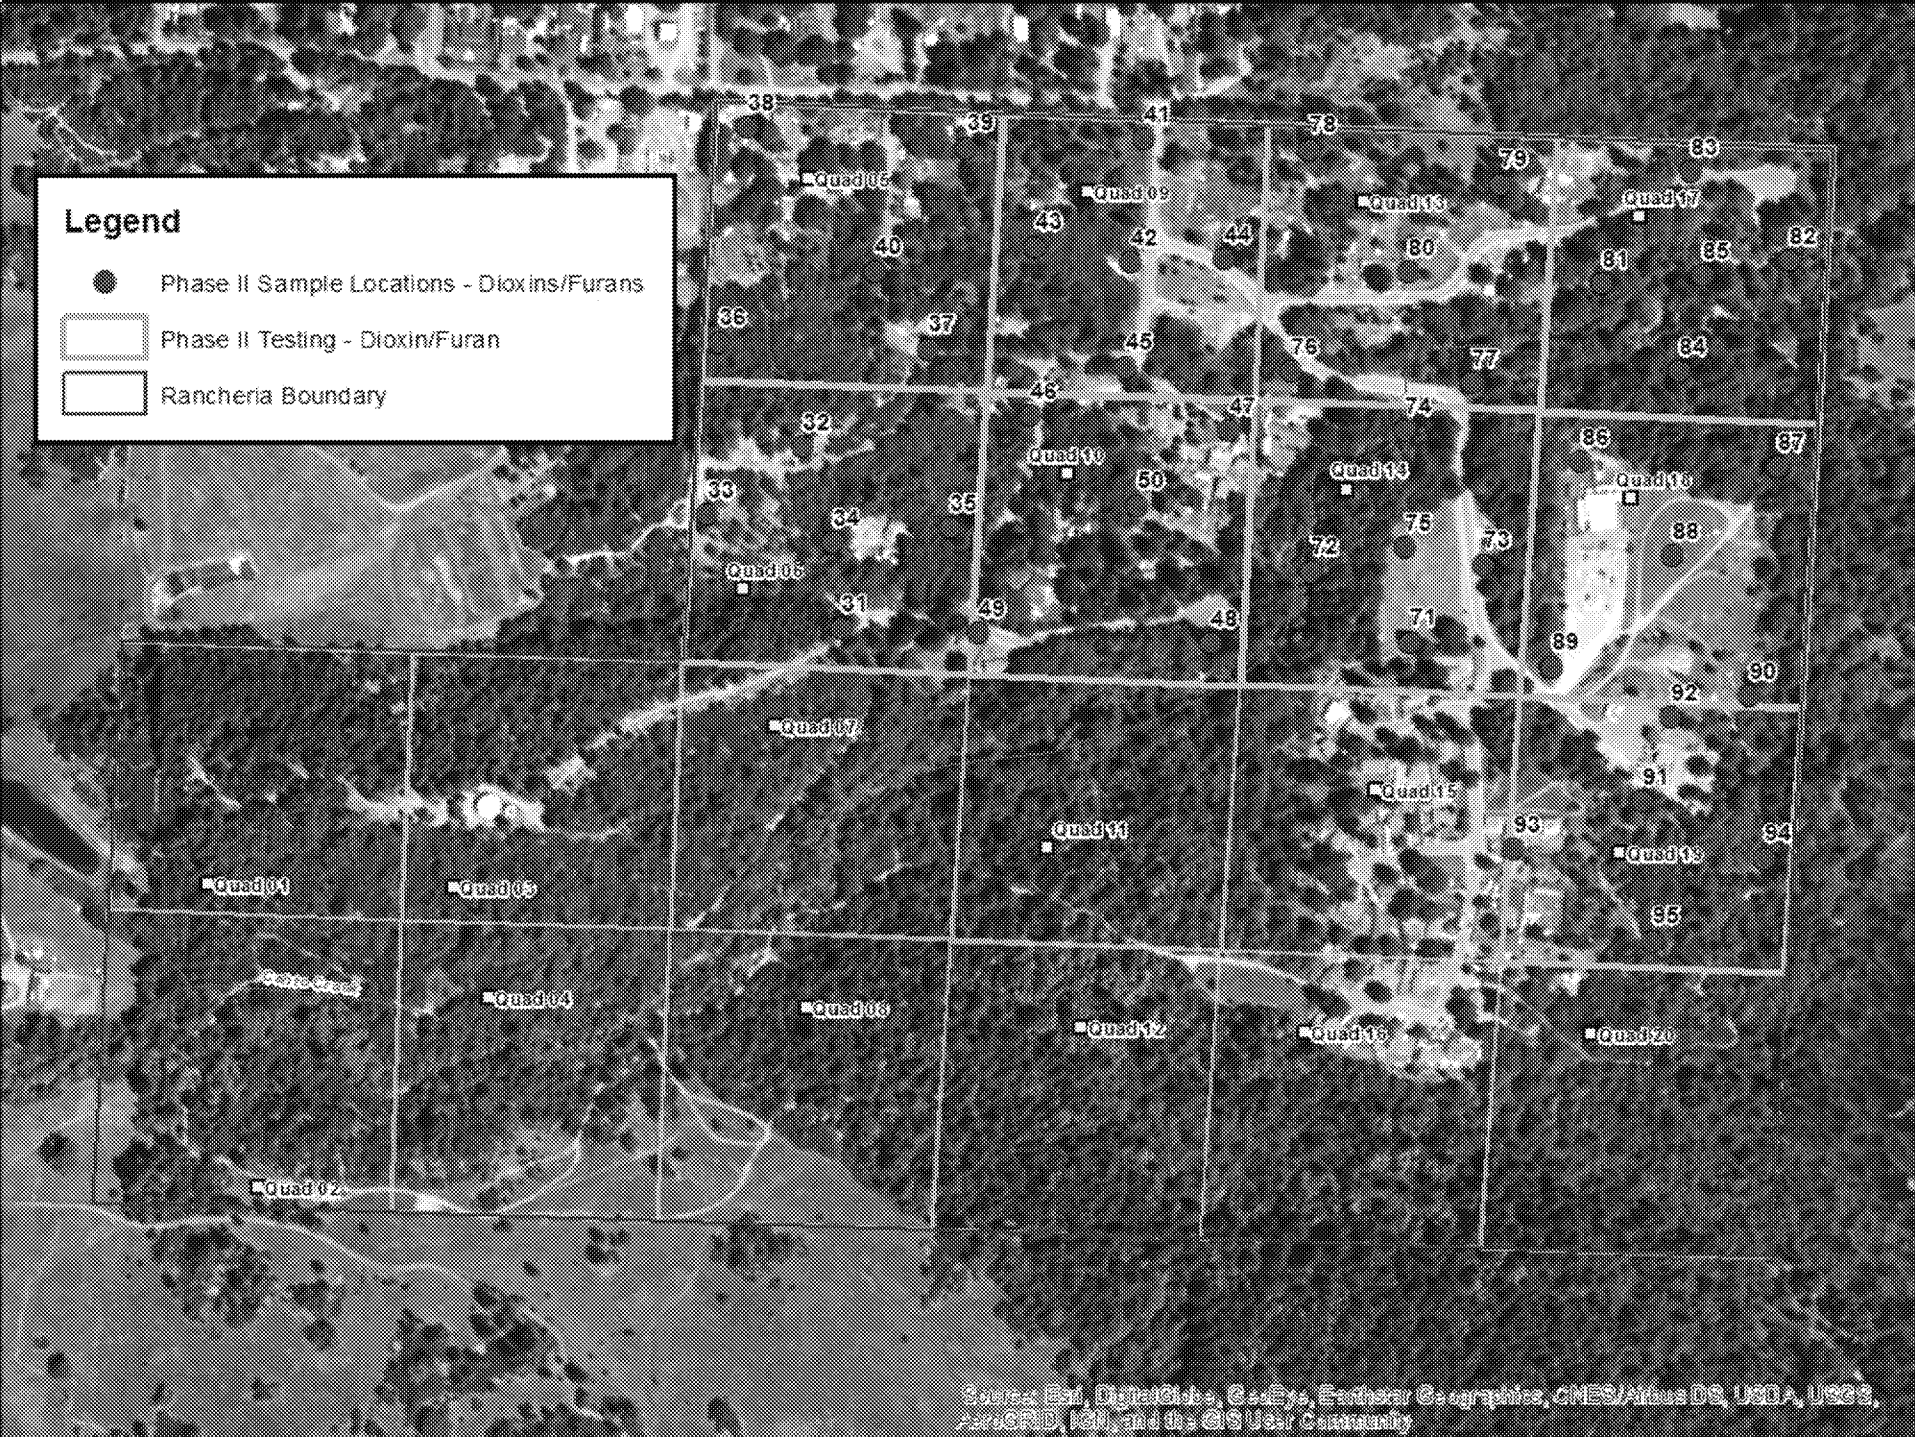
● Phase II Sample Locations - Dioxins/Furans
